Cross Joint Type Flexible Coupling

Backlash Free, Cap Screw Fixing : 0.3 - 12Nm, 3 - 20mm Bores

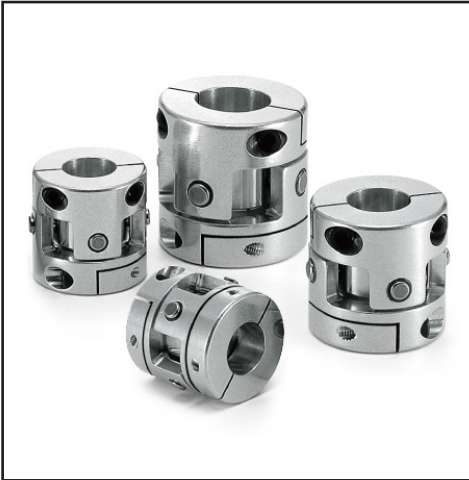
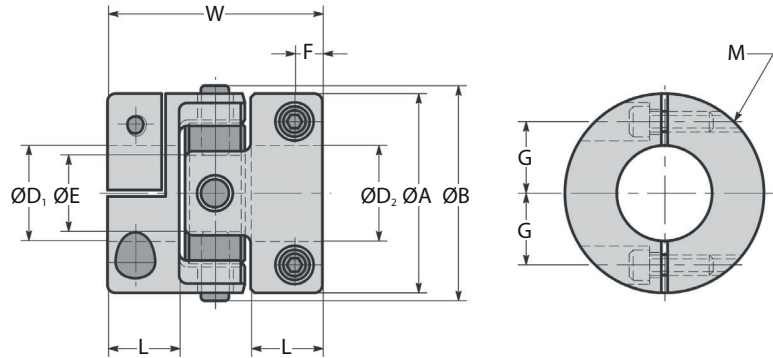
Hub: Aluminium A2017
 Spacer: Stainless Steel SUS304.
 Bearing Pin: Hardened Steel SUJ2.
 Bush: Abrasion resistant polyimide.
 Cap Screw: Steel SCM435 Black Oxide Coating.
